Big Spring Run Floodplain Restoration

mostcenter.org/casestories

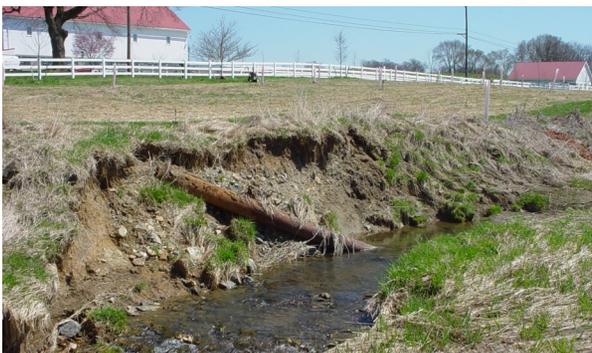
Floodplain before restoration

Big Spring Run, a headwater tributary of the Conestoga River, was characterized by severe streambank erosion and degradation. The stream valley had been filled in by nutrient-rich sediments generated by historical land-use practices, including 19th century milldams located along the stream. Streambank erosion was contributing to over 60 percent of the sediments suspended in the stream flow. The release of nutrient-rich sediments was impacting downstream water quality.

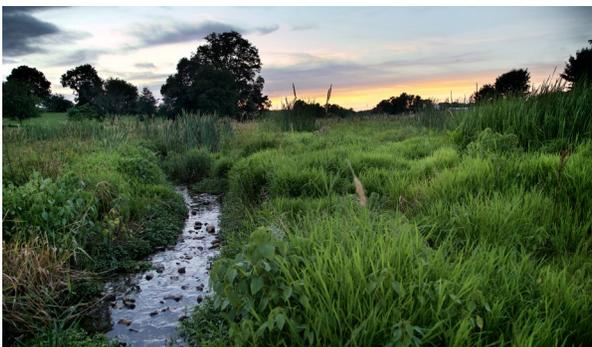
Functioning floodplain after restoration

The floodplain restoration was designed to return the bottom of the stream valley to its historical conditions by removing legacy sediment and establishing a wetland-meadow valley bottom complex. The restored area is no longer a sediment source. It now traps fine sediment and has improved water quality on-site and downstream, provides additional storage for flood water, and improved groundwater recharge.
