## Bacon Ridge Stream Restoration

## Key Project Facts

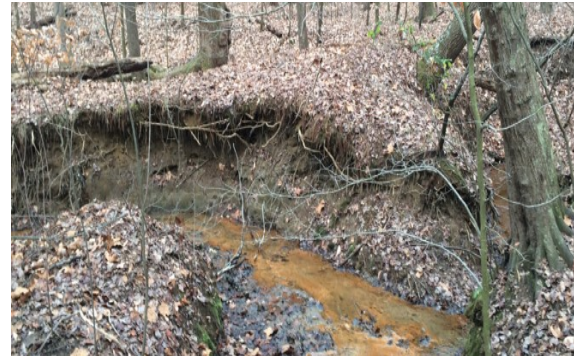
**Before:** The stream was becoming unstable. Headcuts like the one shown above were getting worse after each storm.

Bacon Ridge Branch, a headwater to the South River, flows through the center of Bacon Ridge Natural Area. Despite strong land protection efforts in the past 20 years, deforestation and development funneled huge surges of stormwater into this stream. This caused over 180 eroded cliff drop-offs called 'headcuts' along the stream which became unstable and degraded.

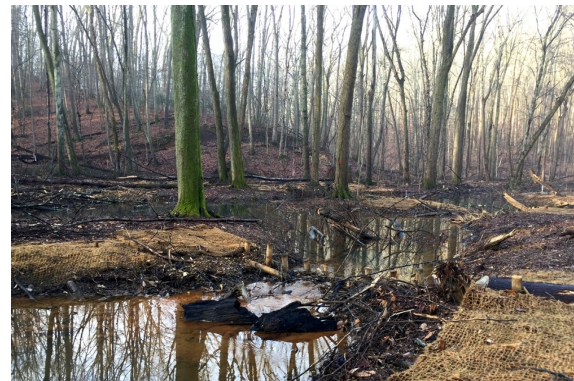
**After:** The beautiful restored stream helps the entire surrounding environment and community.

**Fighting climate change:** The team installed log jams made from wood harvested on site that absorb energy and slow the flow of stormwater. Not only does this make it resilient to stronger storms, but by not importing materials from other sites, the project's carbon footprint is much smaller than standard stream restoration projects.
