## St. Luke's Episcopal Church Restoration of Nature

**Project Location:** Annapolis, MD

**Type of Project:** Stream restoration

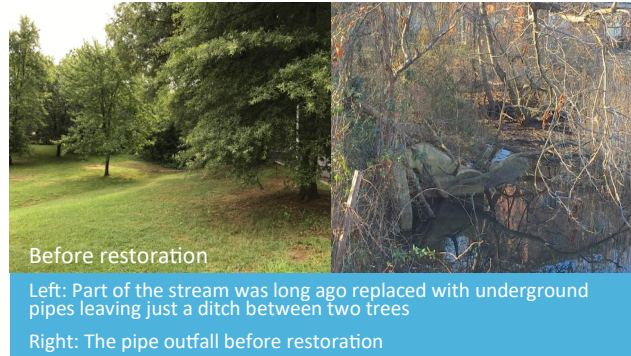
Before restoration

Left: Part of the stream was long ago replaced with underground pipes leaving just a ditch between two trees

Right: The pipe outfall before restoration

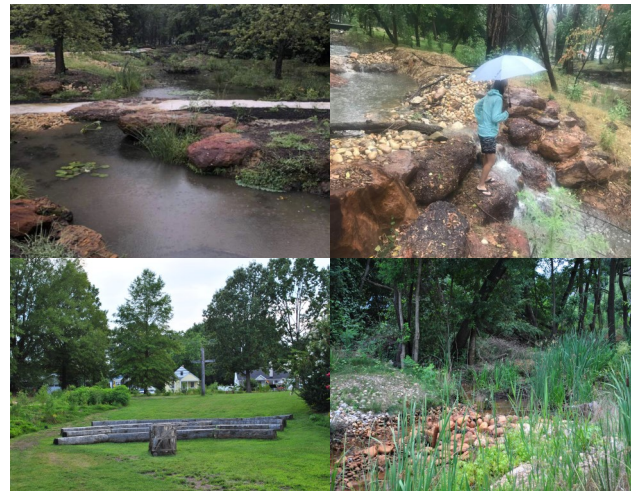
After restoration: A healthy, balanced ecosystem

St. Luke's decided to take action and "care for creation" - a massive stream restoration project. The project recreated a historic stream, wetland, tidal marsh, and living shoreline with over 9,000 of 100 plant species placed throughout the site. The pipe system that discharged directly into Back Creek was raised to capture runoff as soon as possible. Polluted runoff now flows down a series of step pools that slow the water and spread it out, allowing water to soak into the ground and replenish the aquifer. At the same time, the water is cleaned as it seeps through the naturalized stream channel.
